THEMATIC MAPPER

(E83-10259) THEMATIC MAPPER FLIGHT MODEL
PRESHIPMENT REVIEW DATA PACKAGE, VOLUME 2,
PART B: SUBSYSTEM DATA (Santa Barbara
Research Center) 287 p HC A13/MF A01

FLIGHT MODEL
PRESHIPMENT REVIEW
DATA PACKAGE
VOLUME II - SUBSYSTEM DATA
PART B
Article IV - 3A

HUGHES AIRCRAFT COMPANY
SPACE AND COMMUNICATIONS GROUP

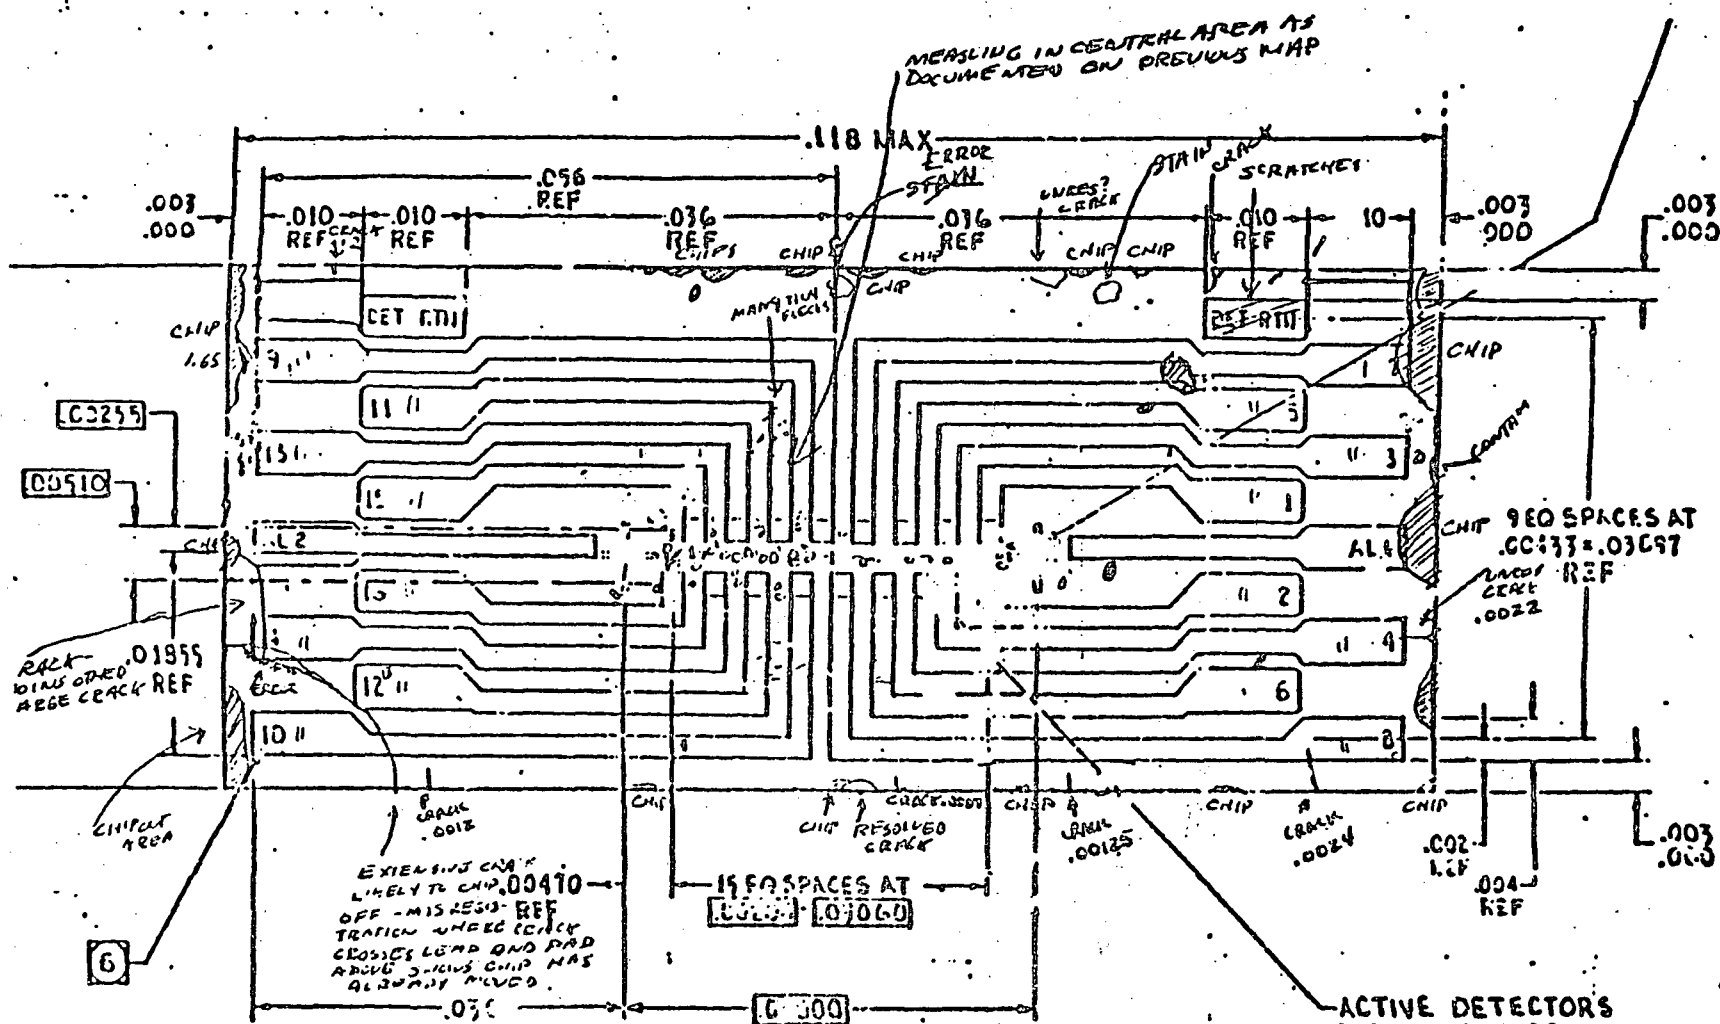
AFTER CLEANING ON MRCO
DIMENSIONS ARE IN MILS

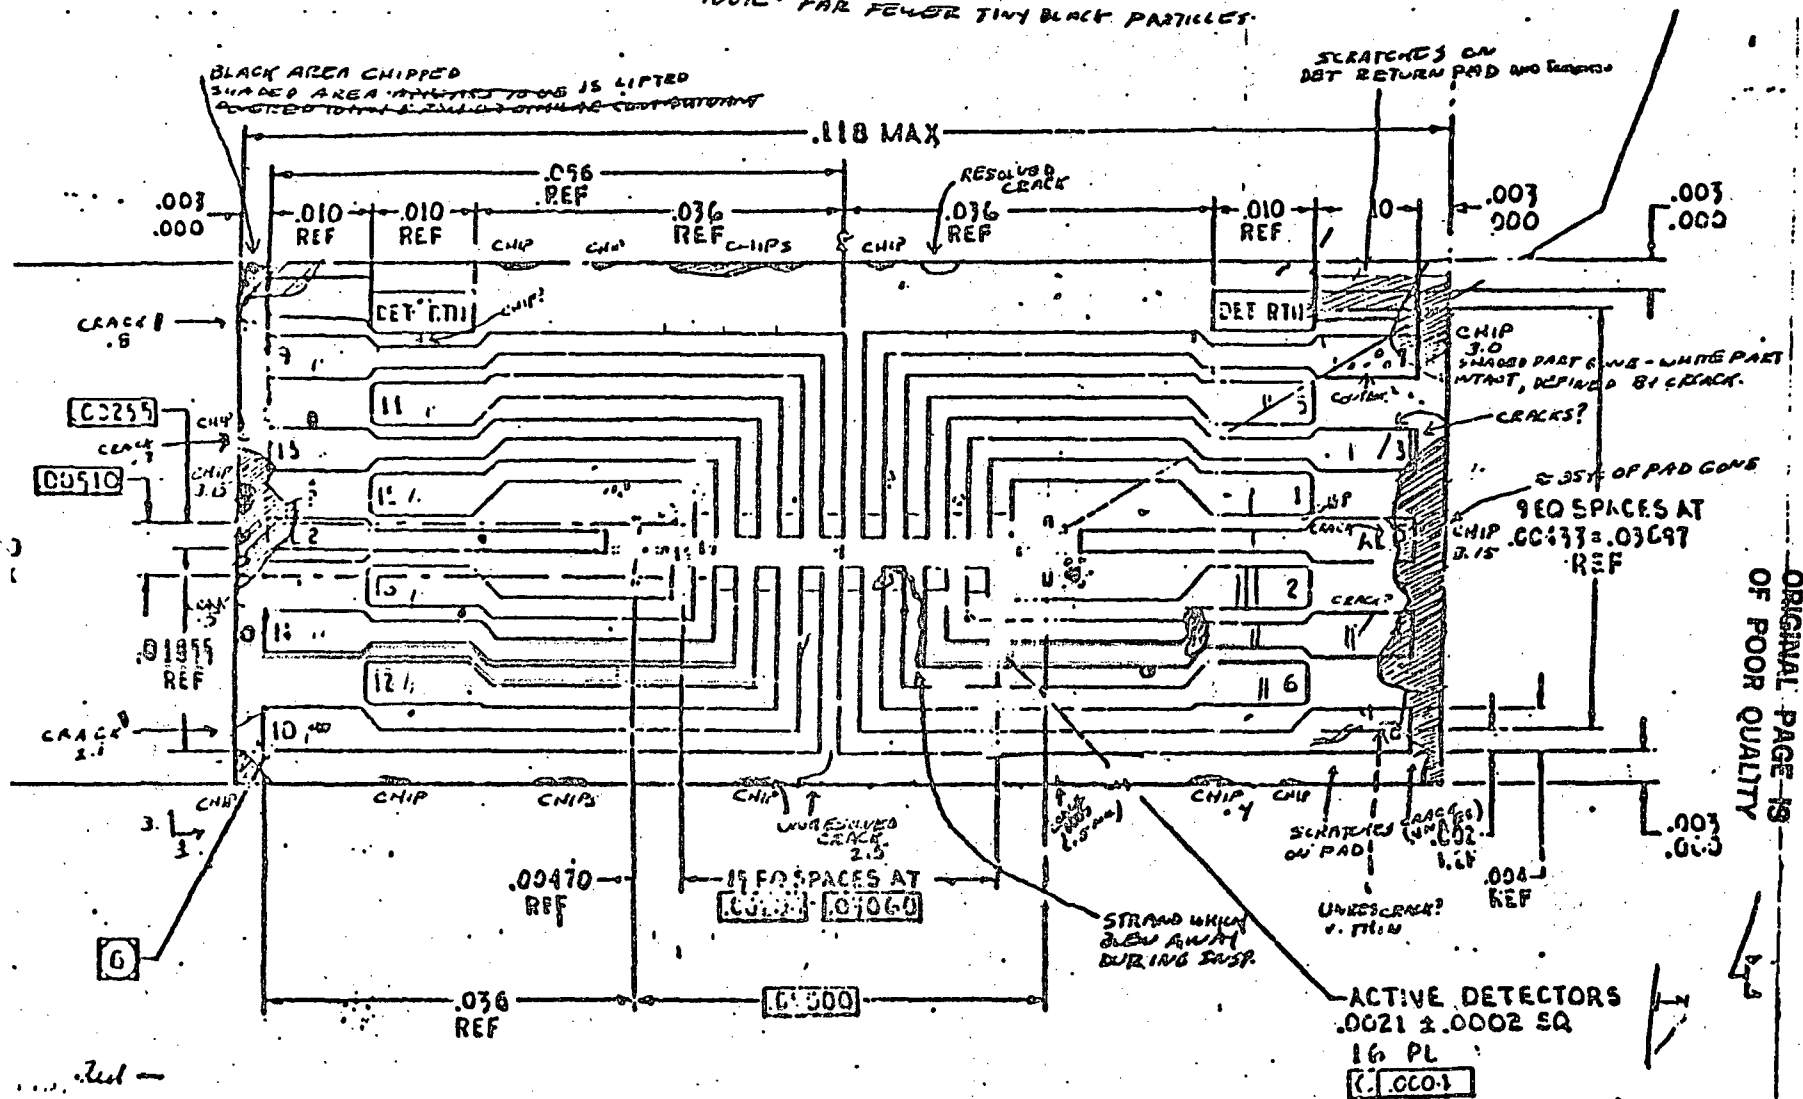
NOTE: FAR FEWER TINY BLACK PARTICLES.

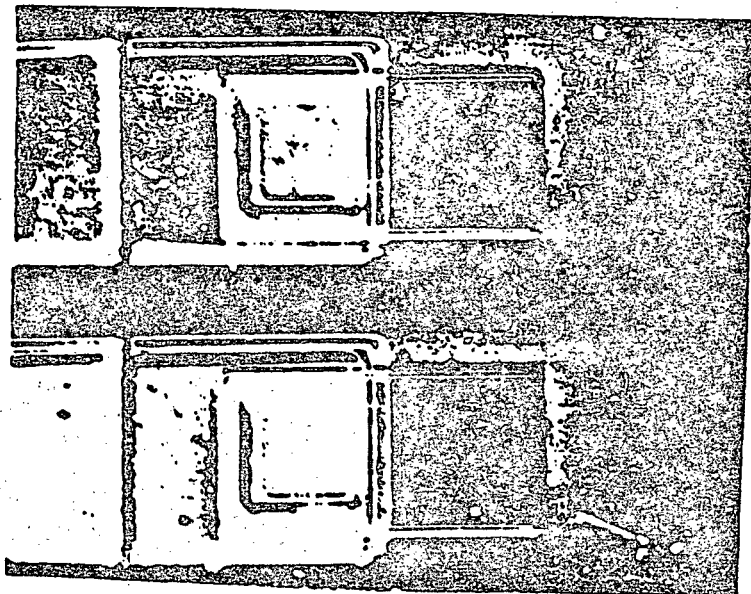
FIGURE NO. 3

Channels 10 and 12, as
received, Nomarski contrast.

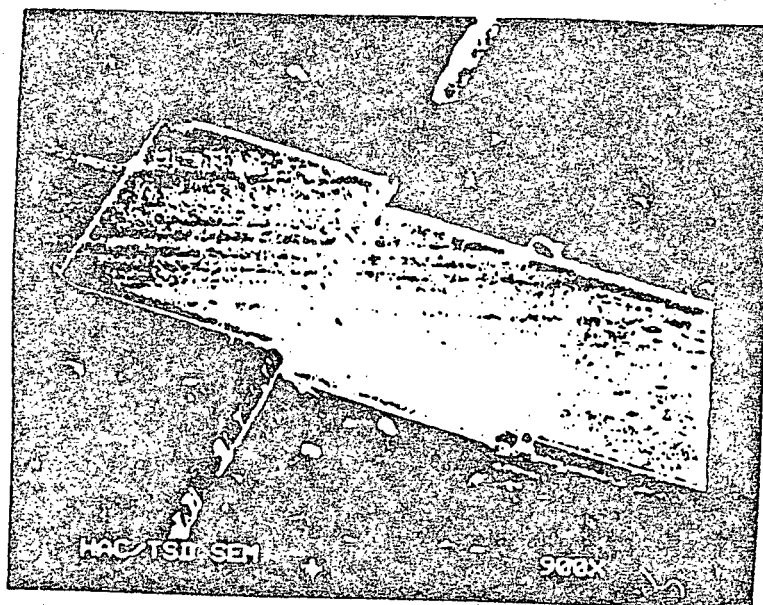
FIGURE NO. 4

SEM of typical diode as
received, showing coverage
at step and thickened
metallization

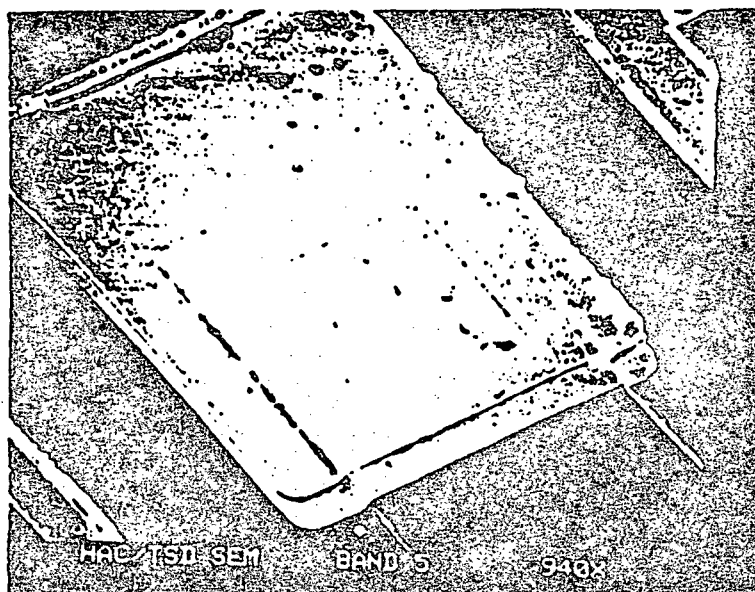
FIGURE NO. 5

Typical diode, Band 5, as received. Clearly shows double metallization, frills at metal edge, possible continuity problem at oxide step.

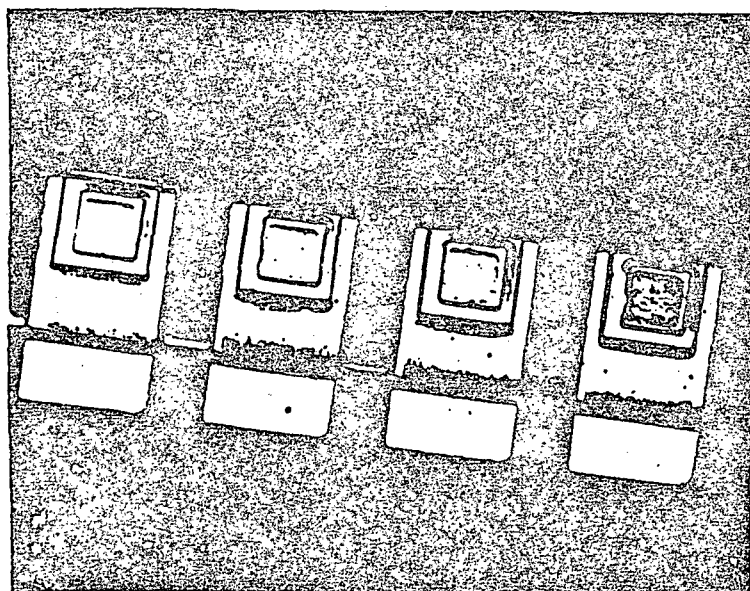
FIGURE NO. 6

(190 minutes sputter etch)
Optical micrograph showing channels 5, 7, 9, 11 (from left). Seven and nine are electrically damaged. Note remaining Ti metal in area of diode; conductor traces are now marked by raised area.

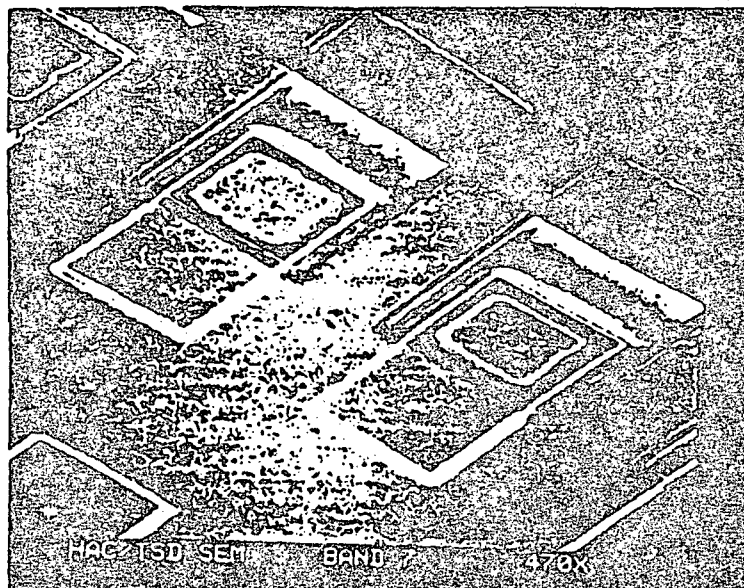
FIGURE NO. 7

(190 minutes sputter etch)
Nearly same area as Figure 6. SEM view showing channel 7 and 9 in center. Oblique view shows groove around mesa. A small amount of residual gold (inner layer) appears at foot of oxide step.

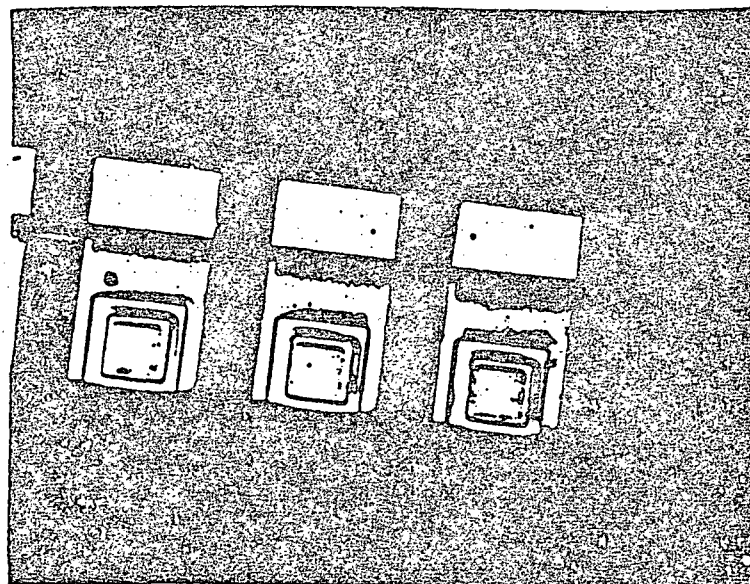
FIGURE NO. 8

(190 minutes sputter etch)
optical view showing channel 12 (damaged), 14, 16 from left. Residual gold shows dark in optical, light in SEM views.

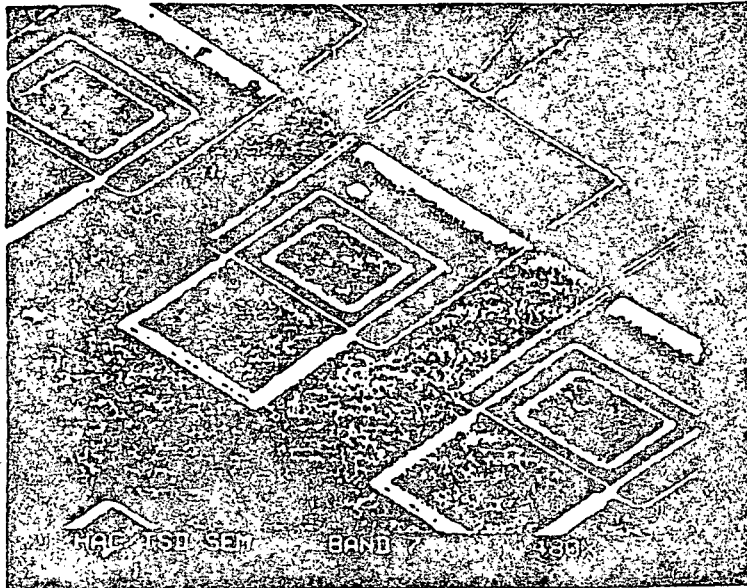
FIGURE NO. 9

SEM showing nearly same area as Figure 8, channel 12 in center. The spot (arrow) on channel 12 is a small area of residual metal probably due to shielding by a dust particle during sputtering.

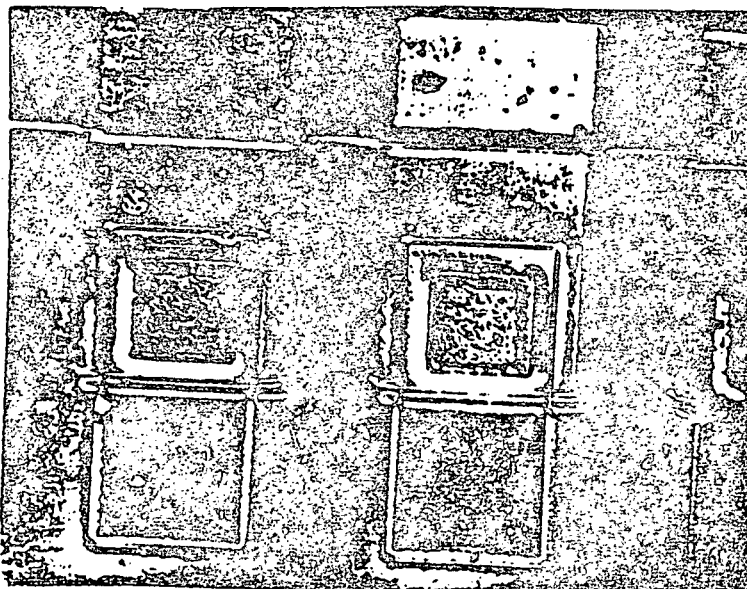
FIGURE NO. 10

310 minute sputter etch, channel 12 (left) and channel 14, optical with Nomarski contrast. A notch has appeared in the left side of the mesa of channel 12.

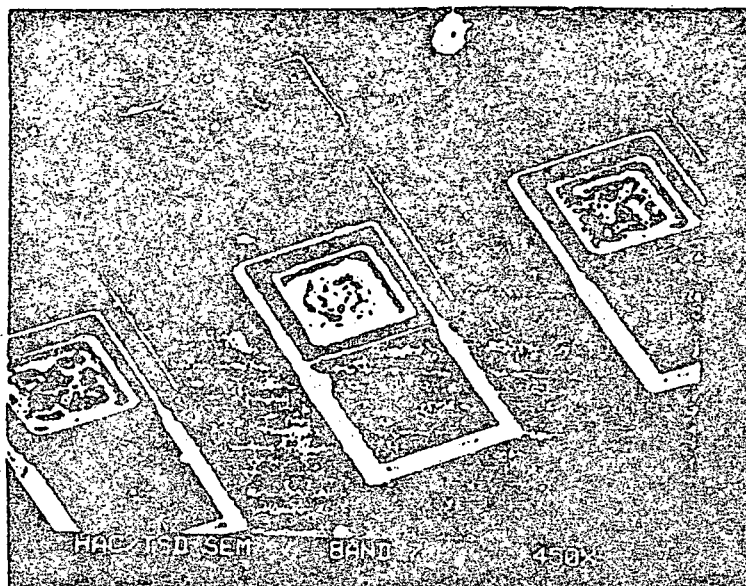
FIGURE NO. 11

Same area as Figure 10,
SEM. Channel 12 in
center. The notch is
clearly shown; note also
a deeper groove around
the mesa than that visible
after 190 minutes.

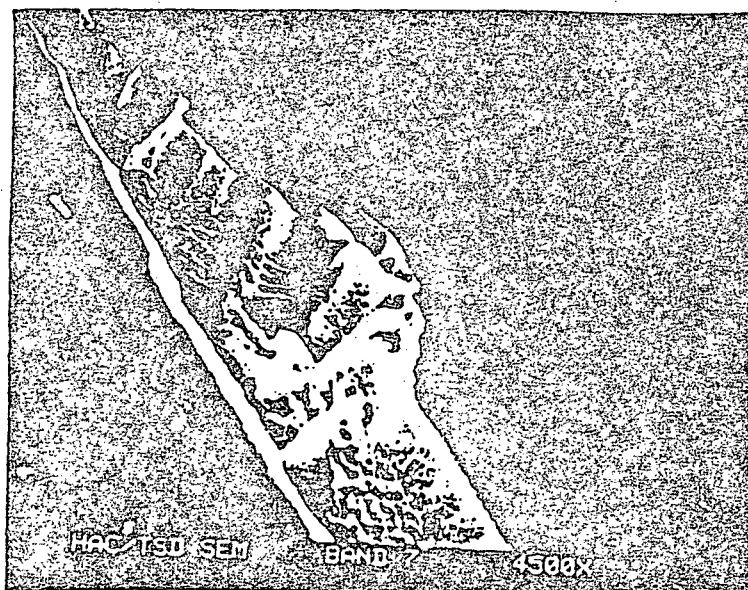
FIGURE NO. 12

Shows the notch under
higher magnification.

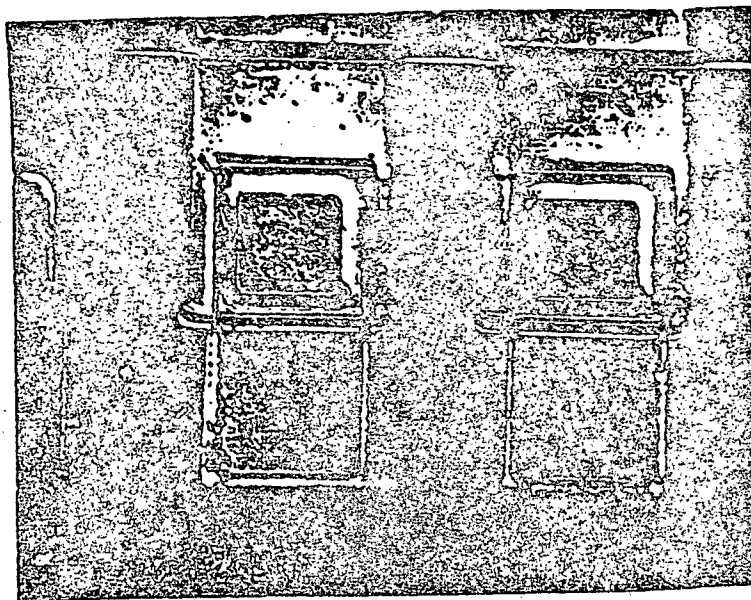
FIGURE NO. 13

Optical, channels 11, 9,
7 (from left). Note
damage on channel 9, at
left edge and upper left
corner of mesa. Nomarski
contrast.

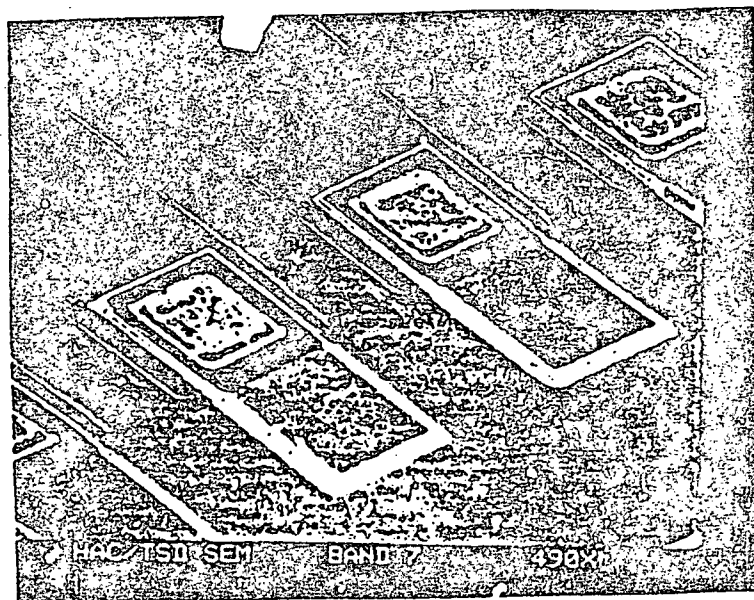
FIGURE NO. 14

SEM showing channel 9 and
7 in center. Same features
are seen plus grooving
around mesa.

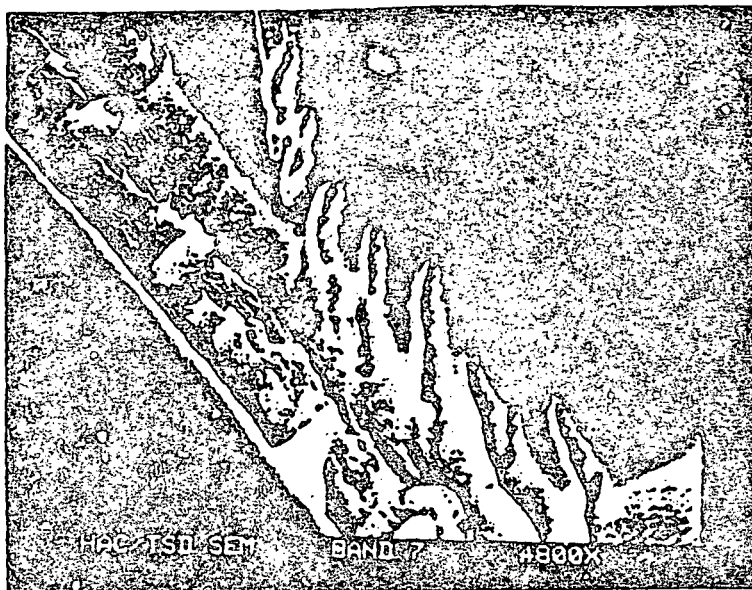
FIGURE NO. 15

SEM showing damage at
left edge of mesa on
channel 9 (compare
Figure 14).

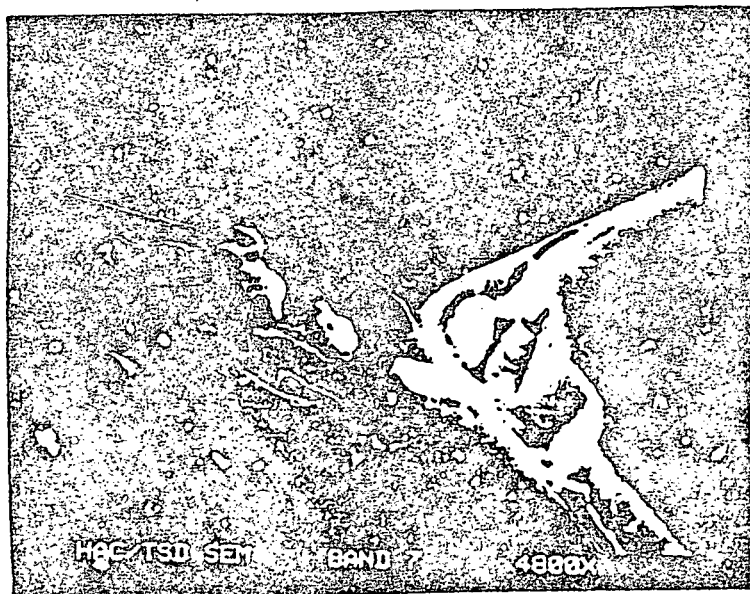
FIGURE NO. 16

SEM showing damage at
upper left corner of
mesa, channel 9 (Figure
14).

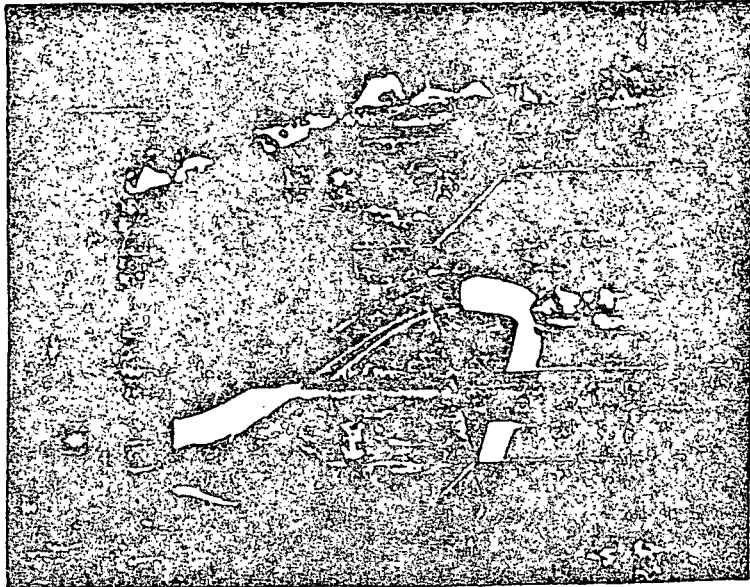
FIGURE NO. 20

Relief shadows of a lead wire, after several stages of sputter-etching. The wire was accidentally moved between stages. Some Ti remains in the last shadow. A crack appears, crossing the shadow. (Optical, Nomarski contrast.)

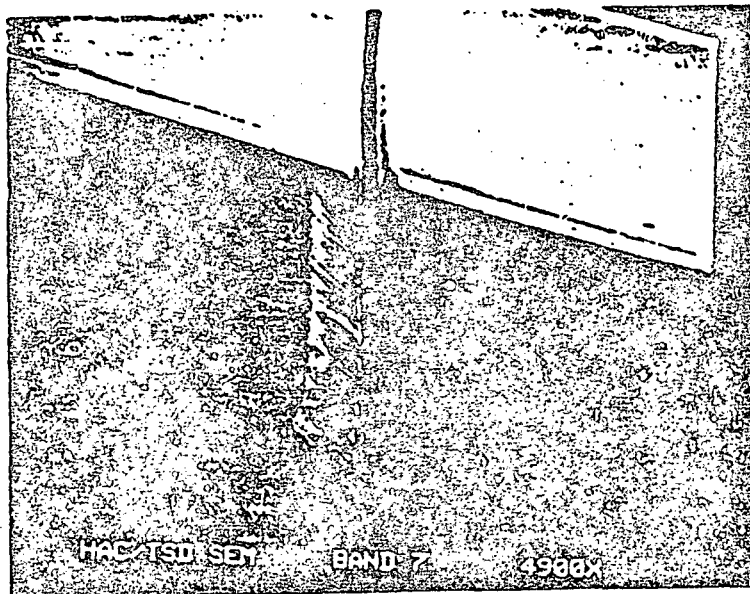
FIGURE NO. 21

SEM of crack seen in Figure 3 showing V-groove enlargement in sputtered area.

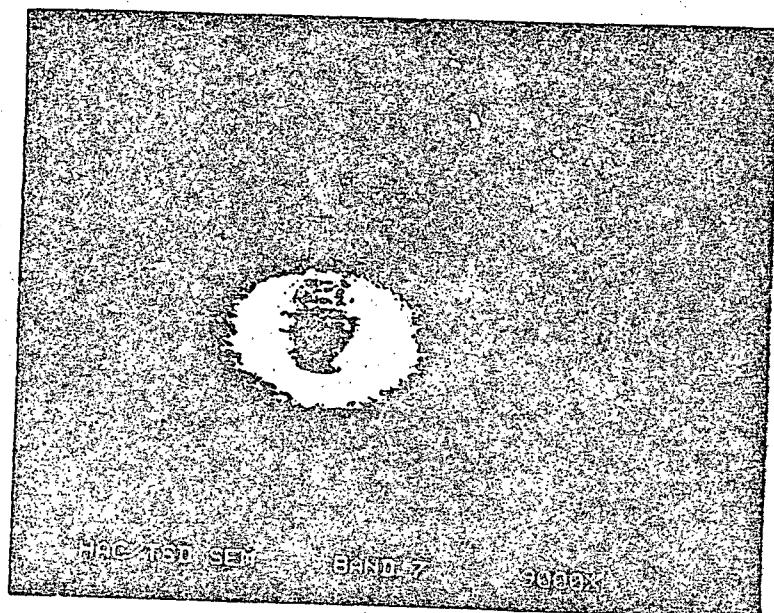
FIGURE NO. 22
Conical pit on mesa
top after 310 minutes
sputtering.
